Toward a Natural Lake Mendota:

Capital Region Advocacy Network for Environmental Sustainability

Lake Mendota Level Recommendations v.2012.03.28

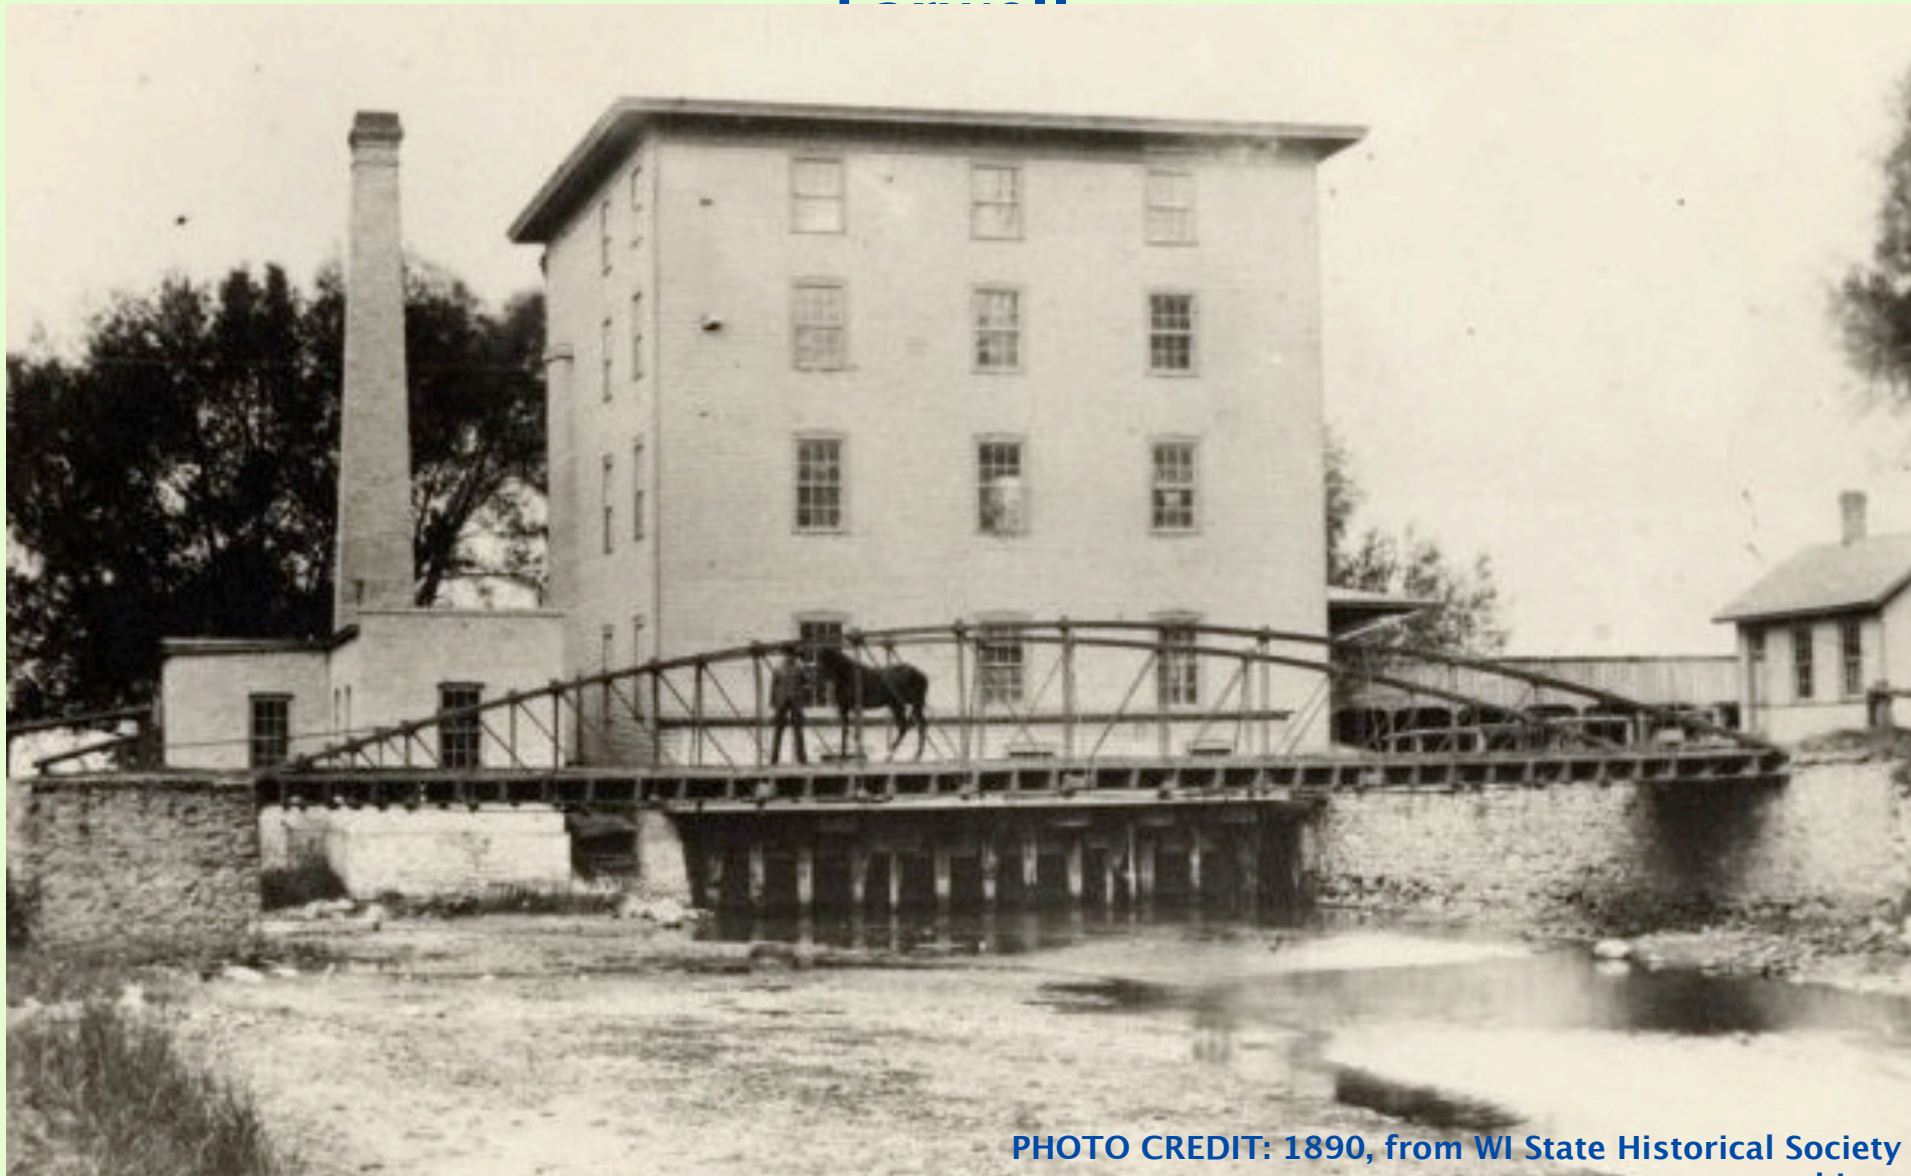
PHOTO CREDIT: 1890, from WI State Historical Society

In 1849, Farwell Dam was built, near the Yahara River's outlet, in the area that is now Tenney Park. The 4-story Madison Mills was owned by Gov. Farwell.

The mill that was created by Farwell Dam created a head that powered then Wisconsin Governor Leonard Farwell's "Mendota Mills."

In contrast, construction of the earliest and largest of the milldams, the Farwell Dam at the outlet of Lake Mendota, ranks among the larger human changes to the watershed. Begun in early 1849 by future Governor Leonard Farwell, the dam raised the level of Lake Mendota 3.5 feet to power the grist mills, lathes and saws of Farwell's "Madison Mills" on the present site of Tenney Park. A thriving business for many years, the wood and earth dam washed out in 1866, but was rebuilt only to have the mill burn twice over by 1894. The once marshy slough between the lakes was dredged and straightened in 1849 as well. The dam was eventually rebuilt with locks to allow navigation to Lake Monona. The dam has clearly been a major influence on Lake Mendota wetlands and water quality to this day.

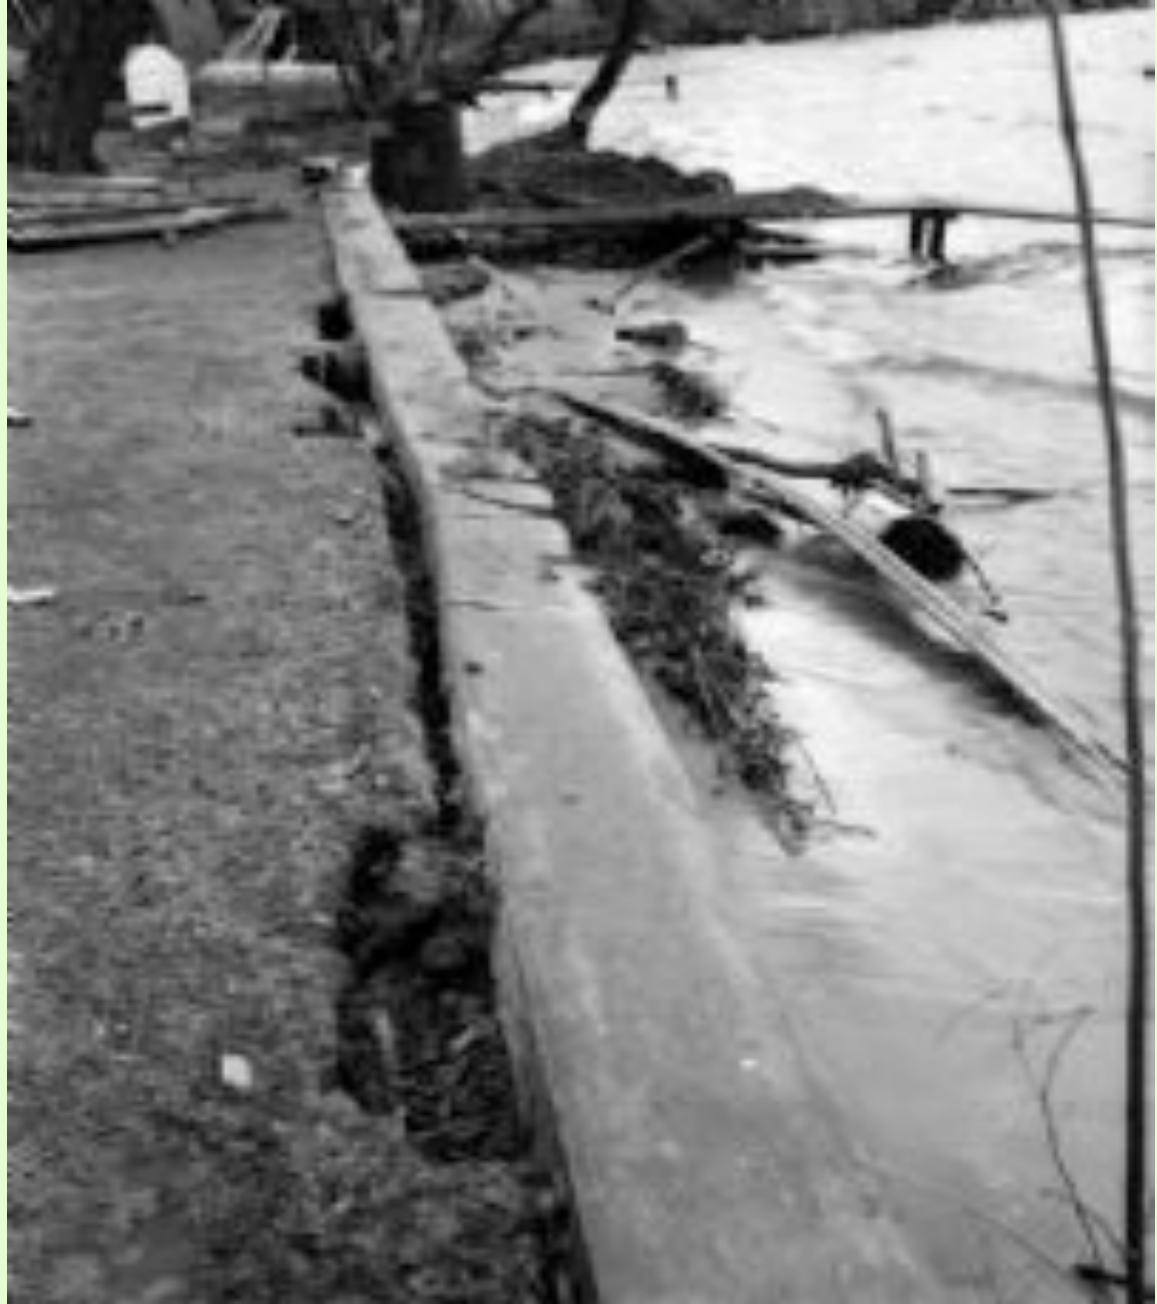
**Ever since the first
dam was built in
1849, high water
has caused damage
to lake shore
properties and civic
infrastructure.**

High Water Damage, 1653 Sherman Ave, 27 APR 1950
Photo: Wisconsin Historical Society

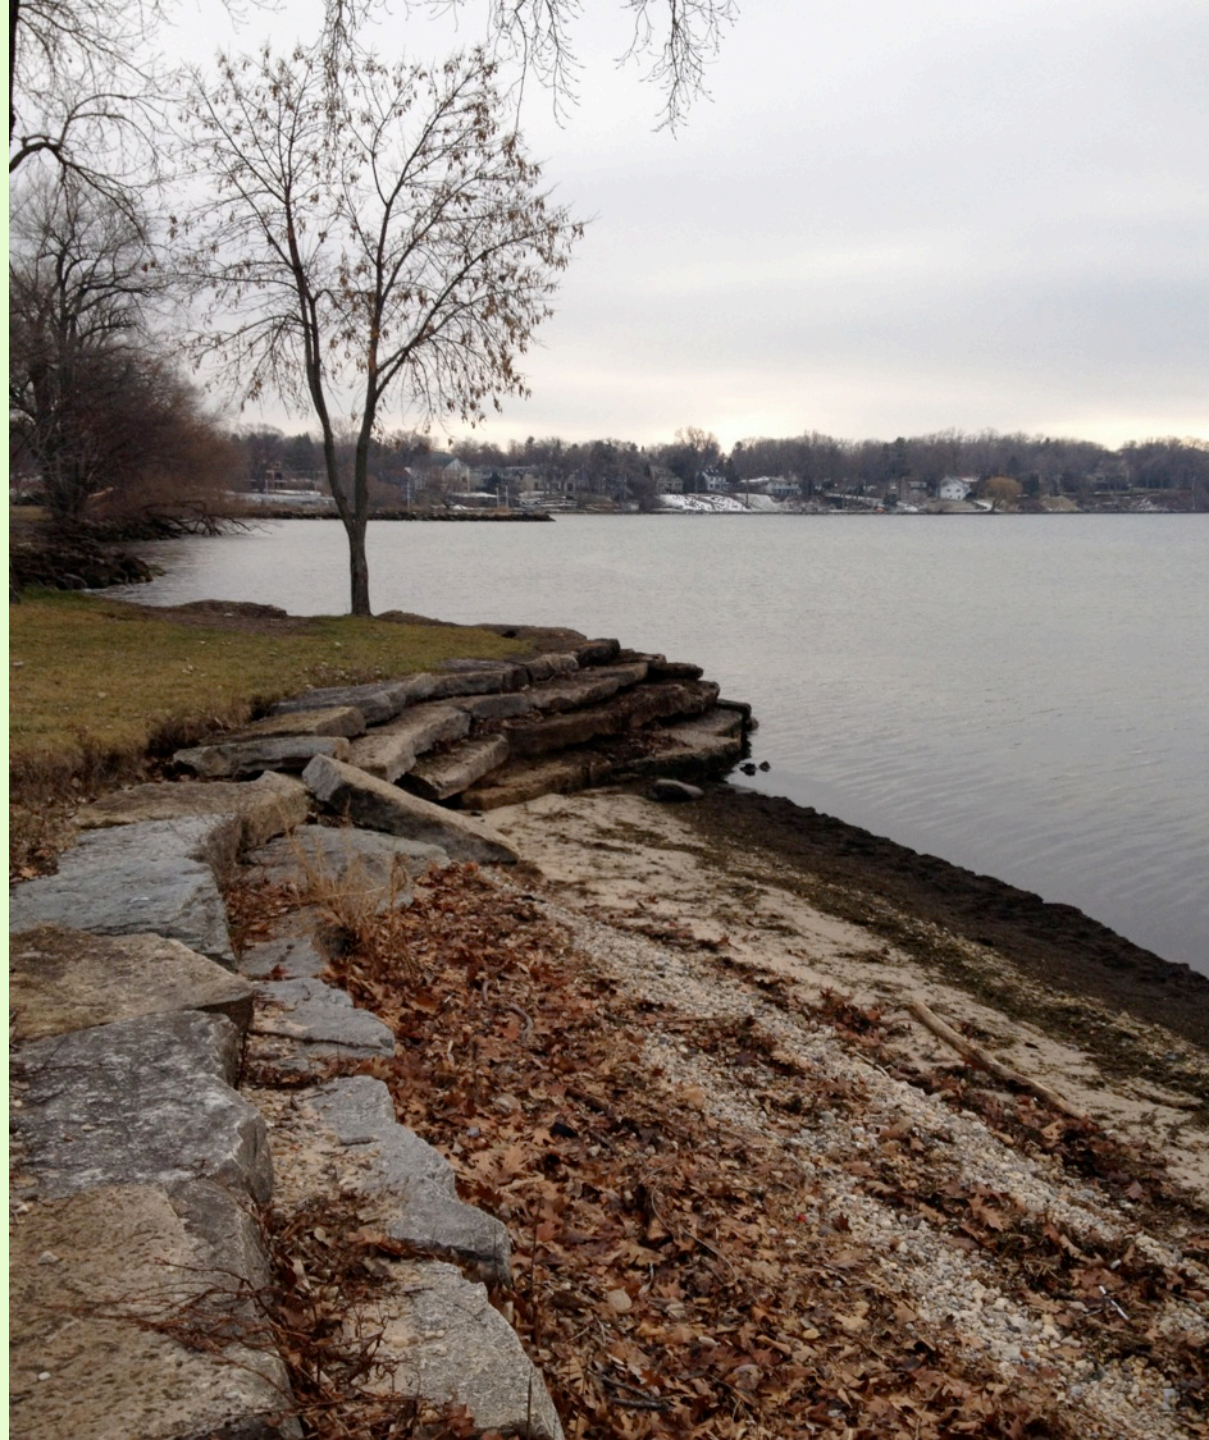
**Taken on 17 December 2011,
when Lake Mendota was at an elevation of 849.12,
or about 6" below the current Summer minimum.**

**Warner
Park
shoreline
structure,
view south**

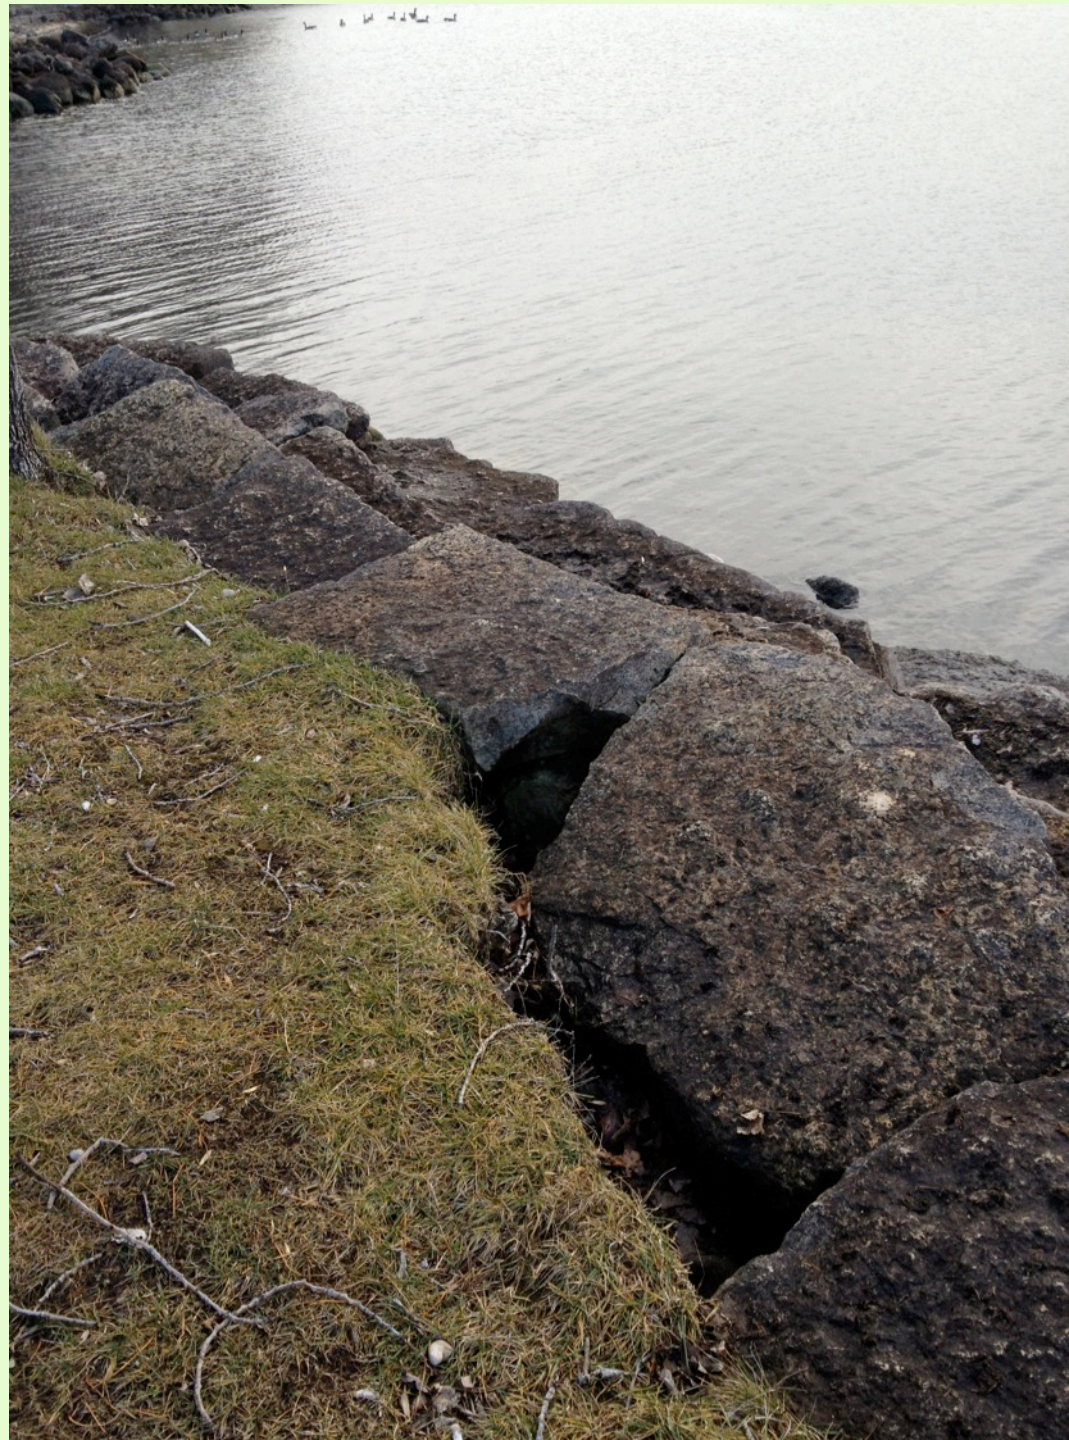
Warner Park, shoreline erosion

*from wave/wind action
at high water levels,
stormwater runoff,
grass sod vs. native plants,
etc.*

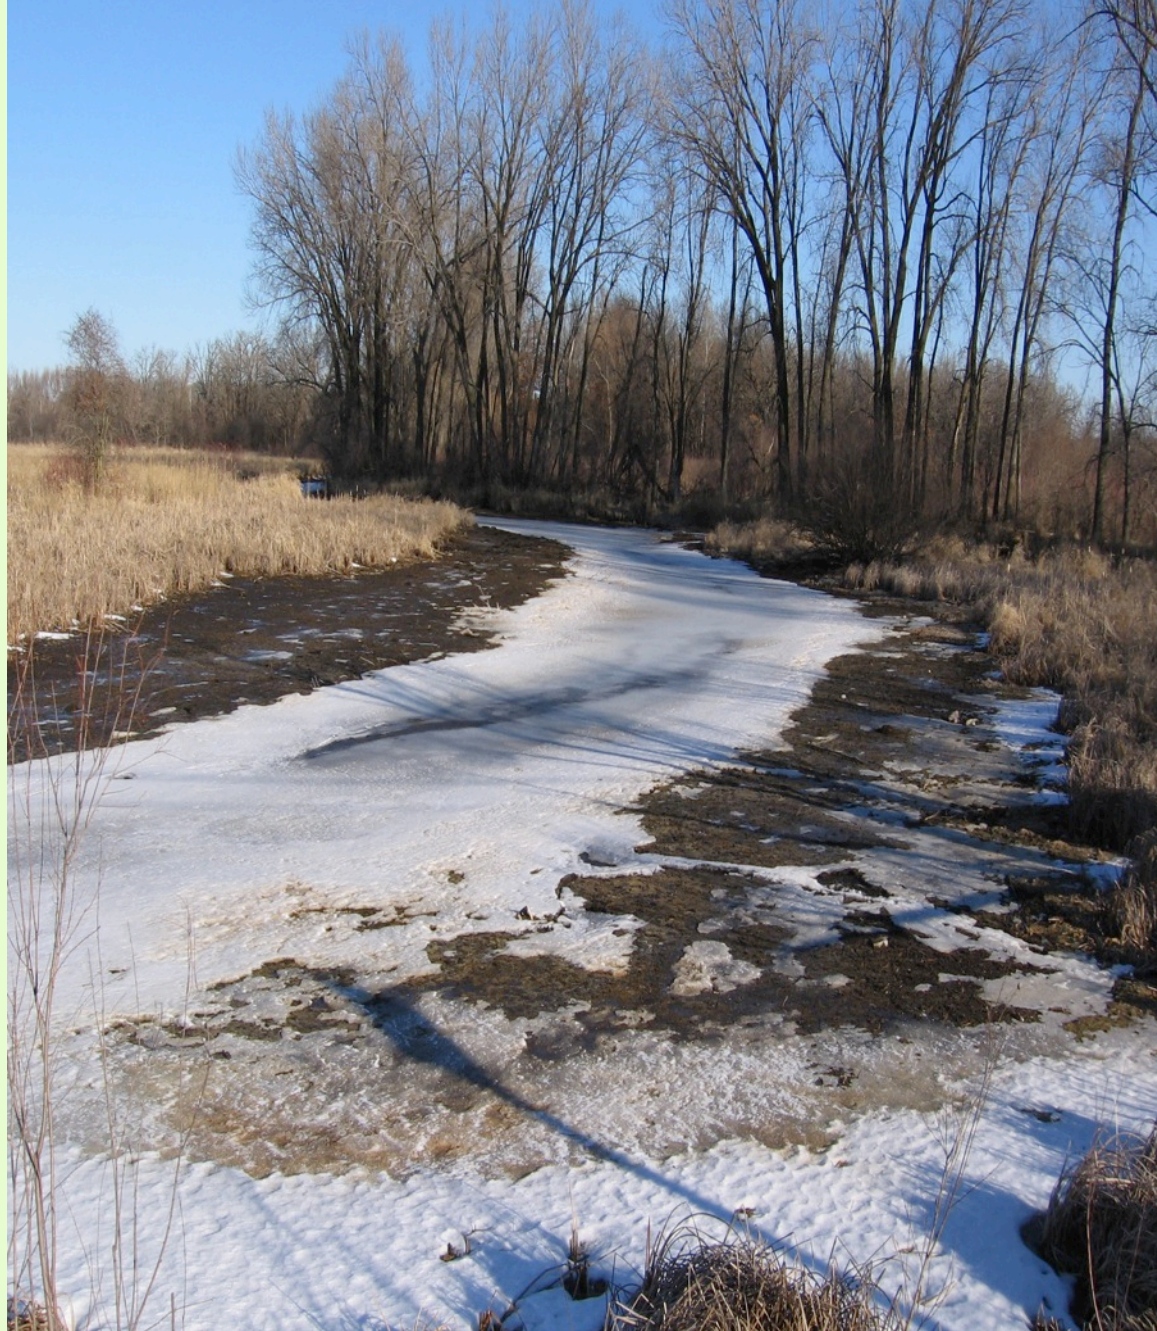
This unnatural
drawdown is done
only to create flood
capacity for the
Spring thaw flood
risk,
which in turn is
caused by the
unnaturally high
Summer target levels
of the 1979 Orders.

PHOTO: Six Mile Creek north of M, water at 848.44,
20 FEB 2012, Si Widstrand

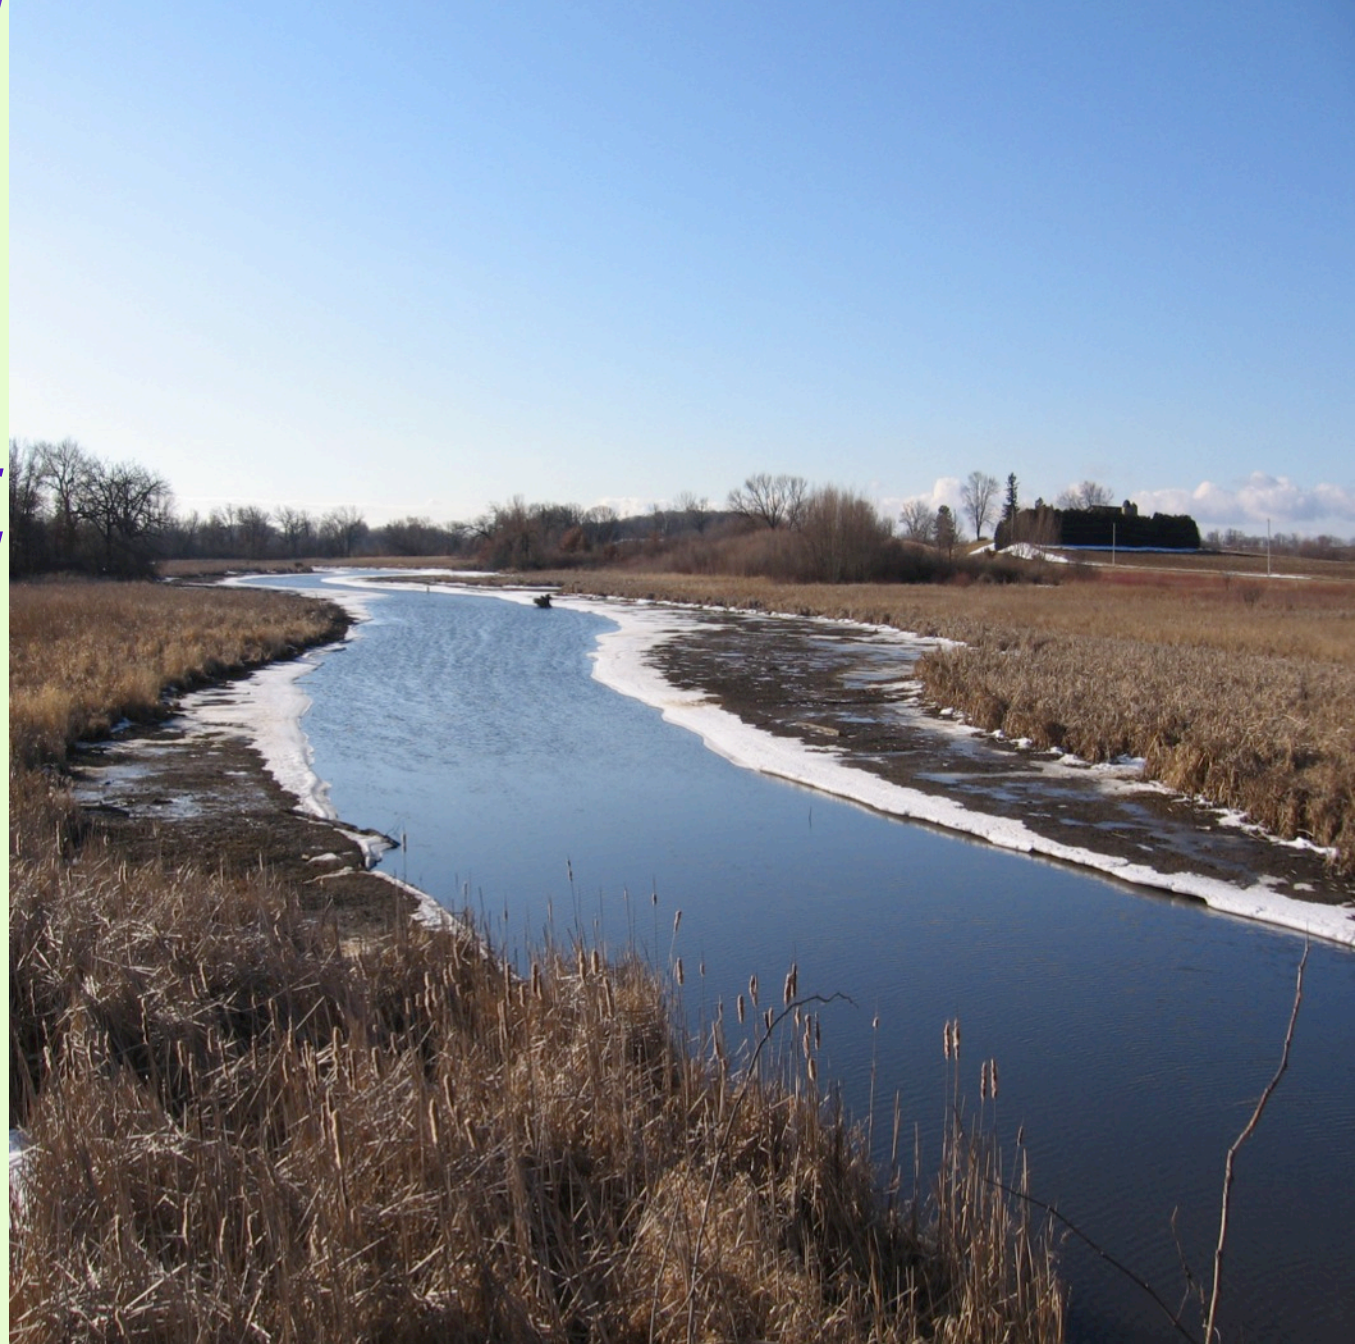
*This radical
seasonal swing
in
Lake Mendota's
level prevents
both
submergent or
shoreland
vegetation from
thriving.*

PHOTO: Six Mile Creek, looking south from CTH M;
20 FEB 2012; Si Widstrand

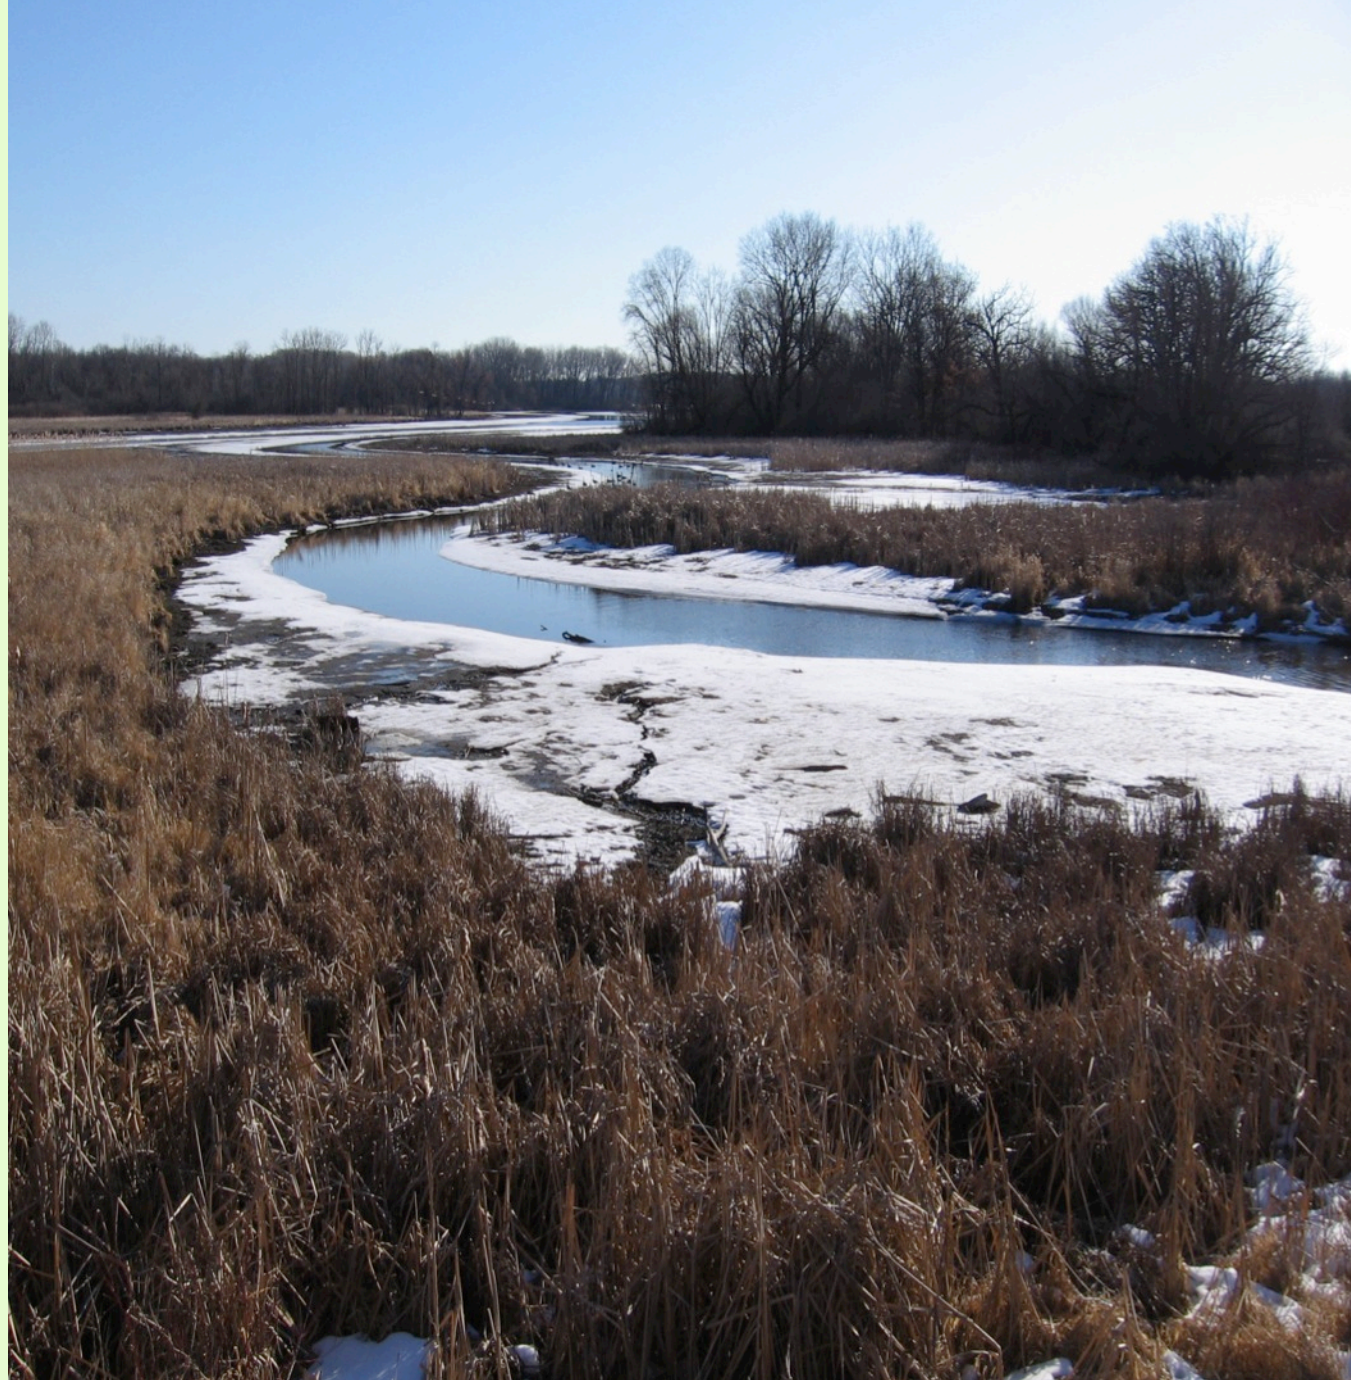
The result:
Barren
shoreland
mudflats in the
winter,
and
barren
stream
bottoms
in the summer.

PHOTO: Six Mile Creek, looking south from CTH M; 20 FEB 2012; Si Widstrand

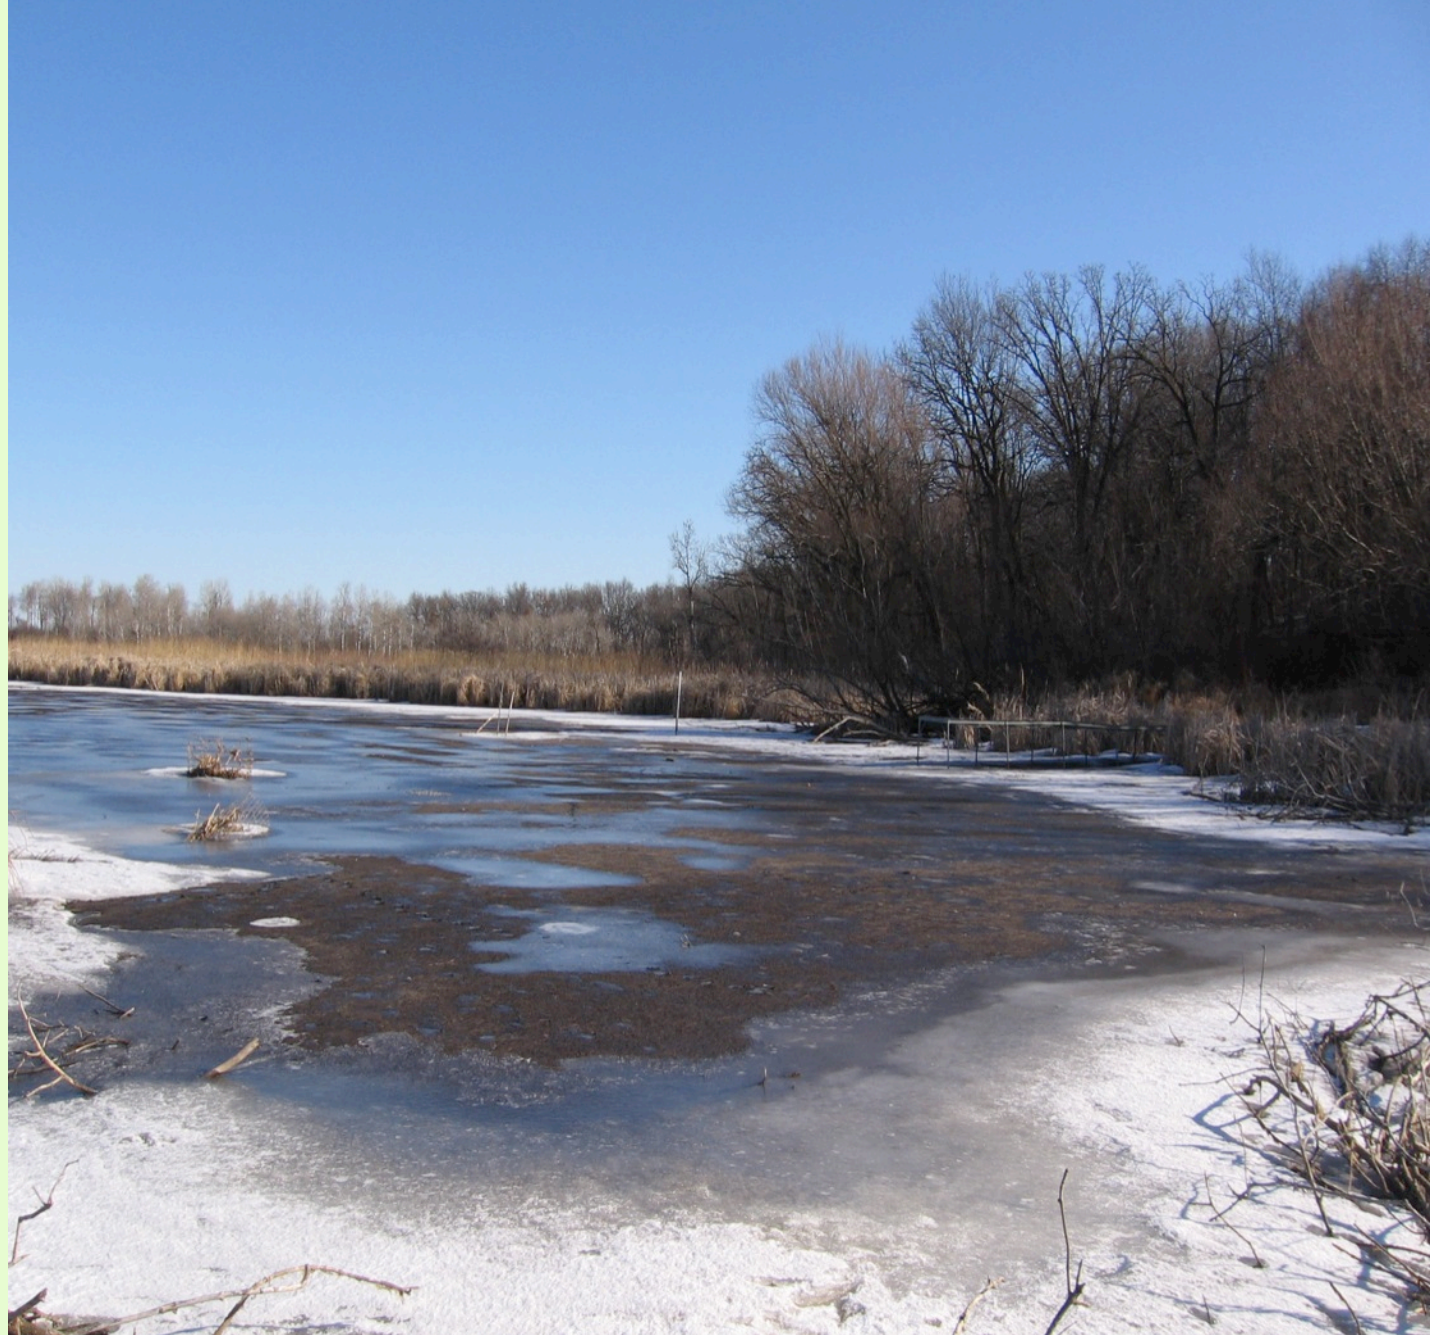
The
extreme
drop to the
winter
minimum
undercuts a
sizable
public
investment
in
shoreland
vegetation
restoration.

PHOTO: Yahara River, off North Unit of Cherokee Conservation Park (north end of “Cherokee Lake”)

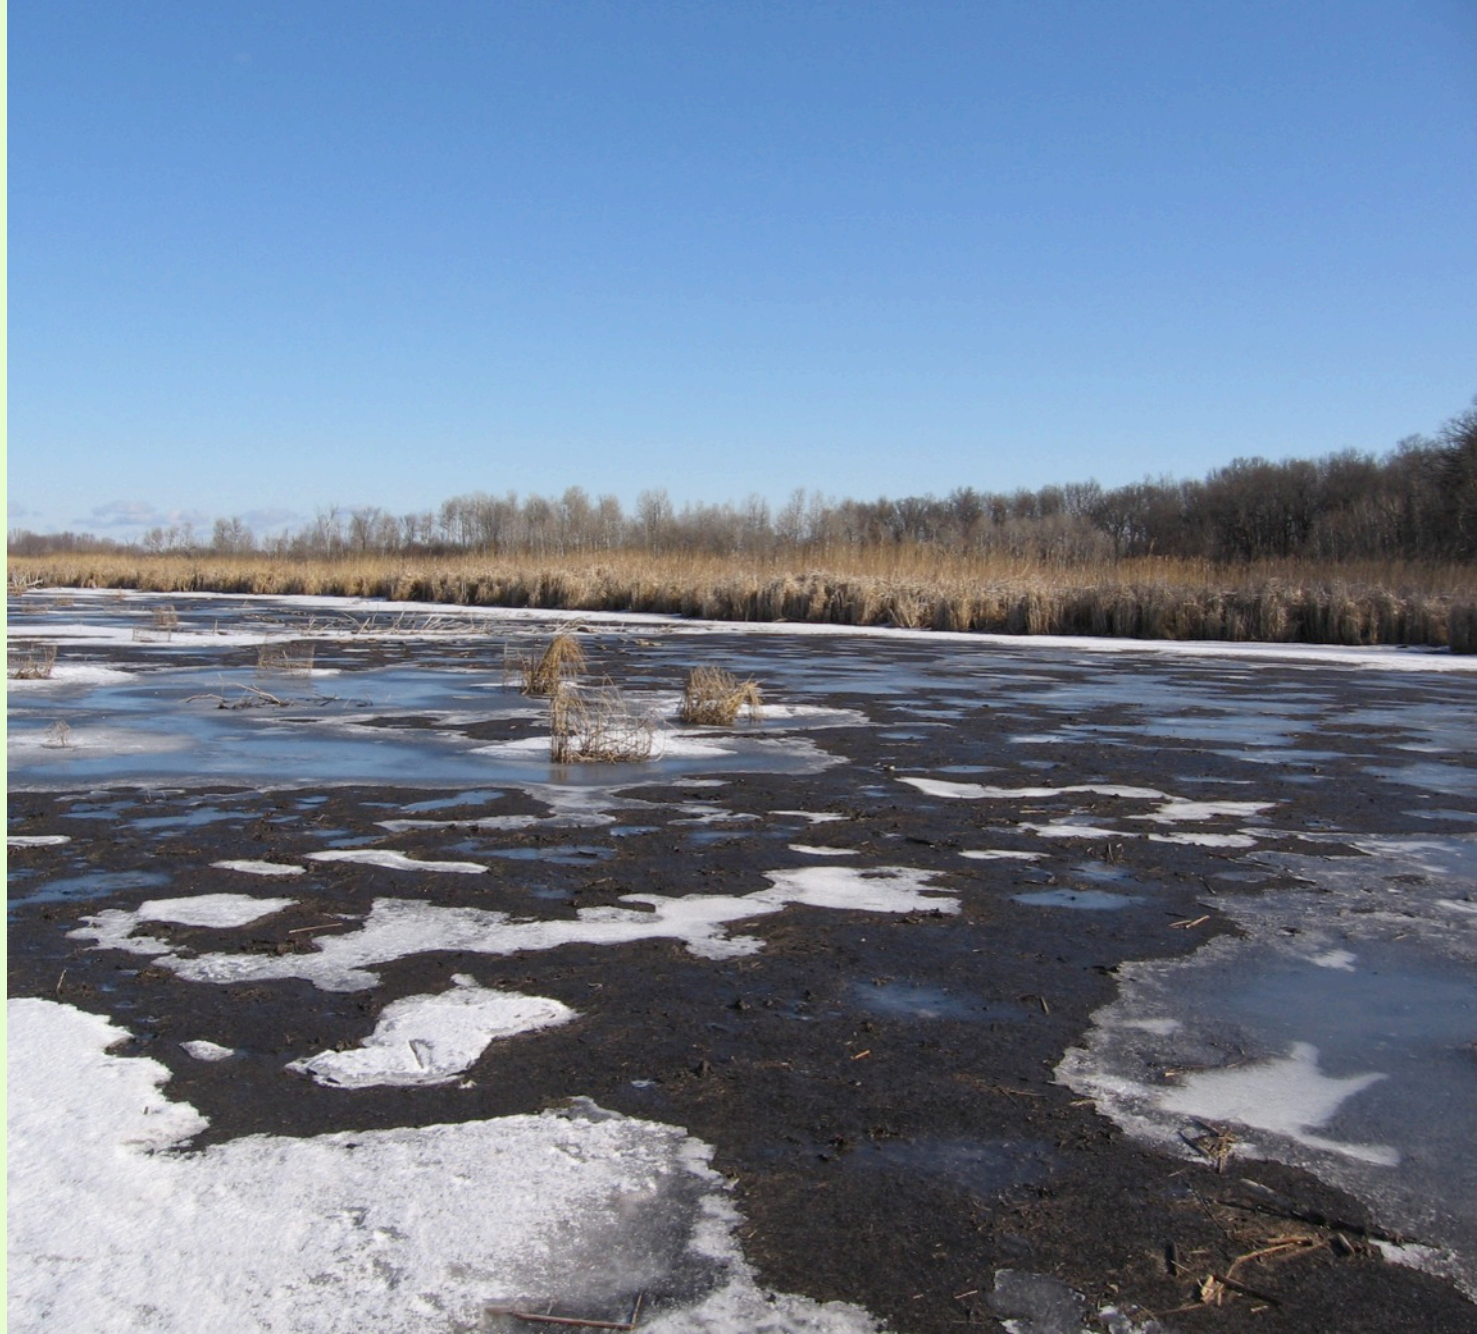
**Winter
mudflats
in the Spring
become a
barren river
bed.**

**PHOTO: Yahara River, off North Unit of Cherokee Conservation Park
(north end of “Cherokee Lake”); 20 FEB 2012; Si Widstrand**

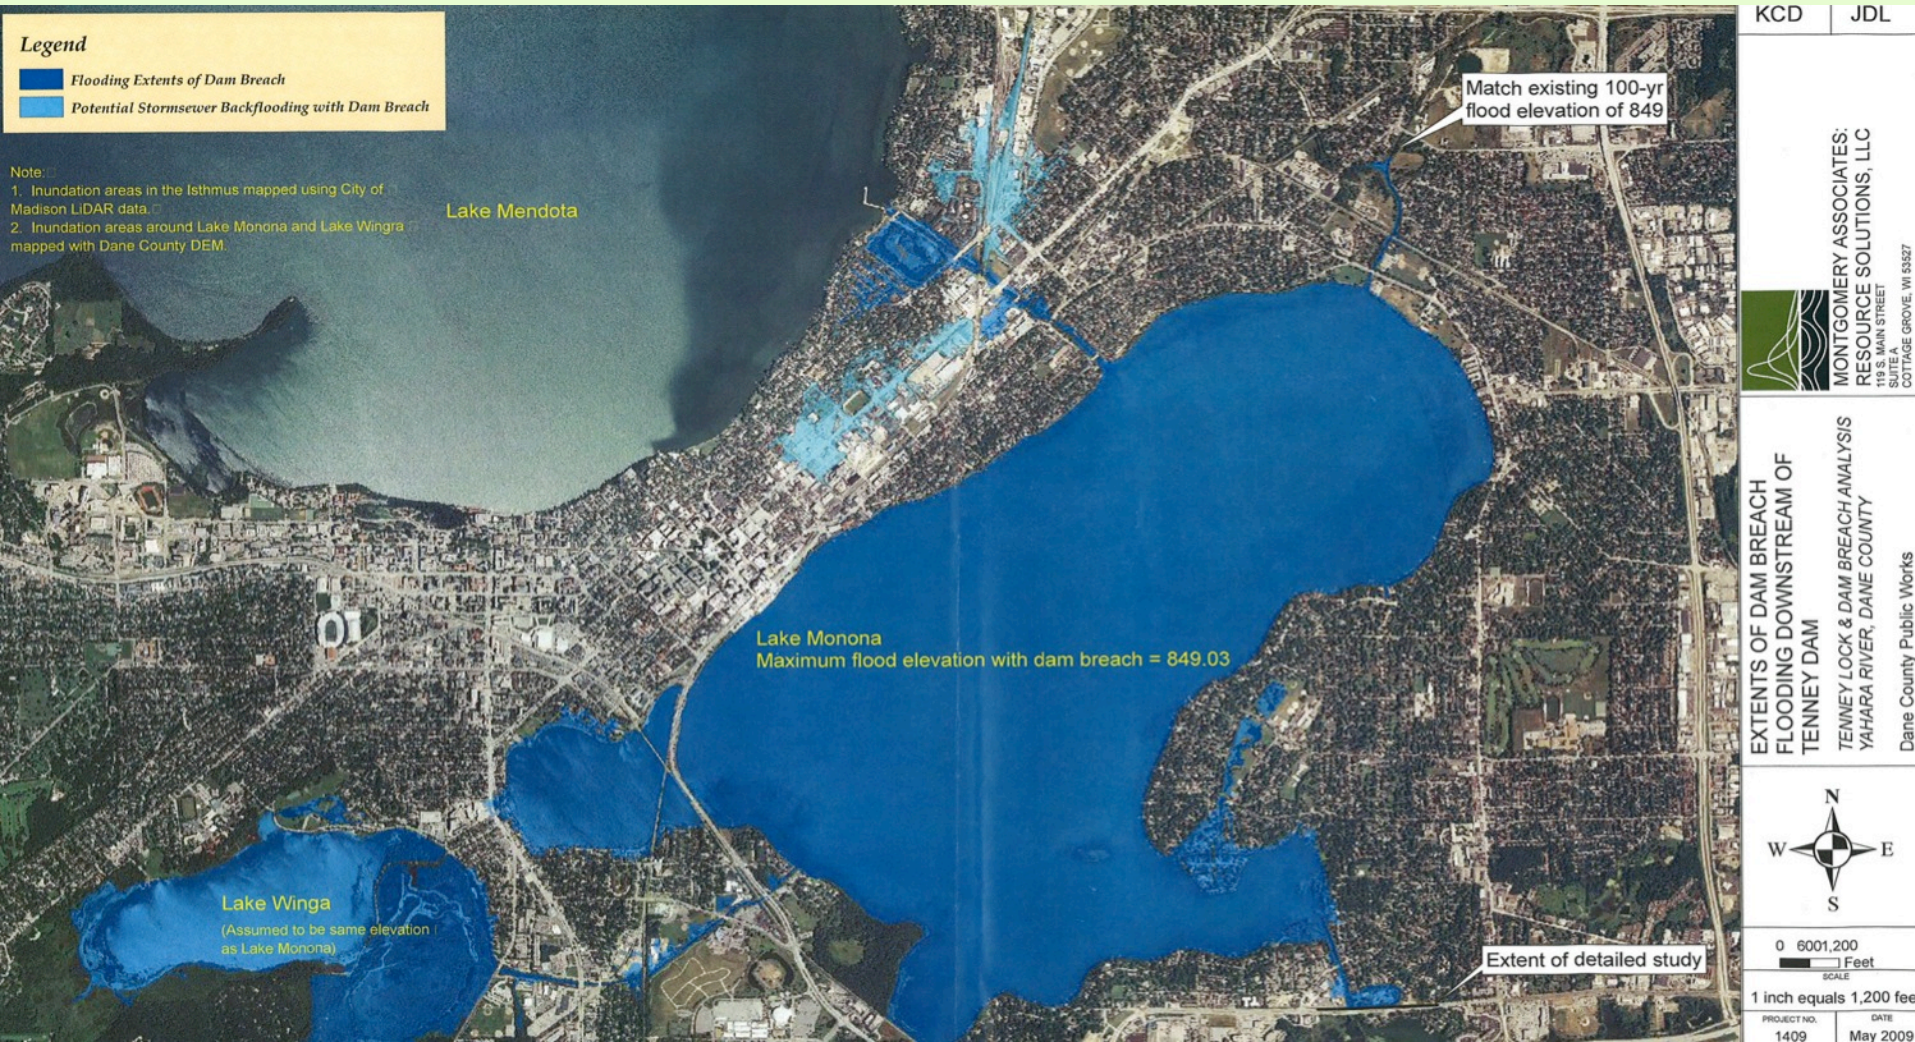
This map from a 2009 study shows the potential impacts of the 100-year flood under different scenarios

FLOODING EXTENTS:

Green = w/dam intact Magenta = w/o dam Dark blue = w/dam breach
Light blue = Potential storm sewer backflooding w/breach.

The dam was recently found structurally sound by engineers, so a breach is unlikely. If breached, there'd be damage near Tenney Park and the Yahara channel, but also further away, due to backflooding.

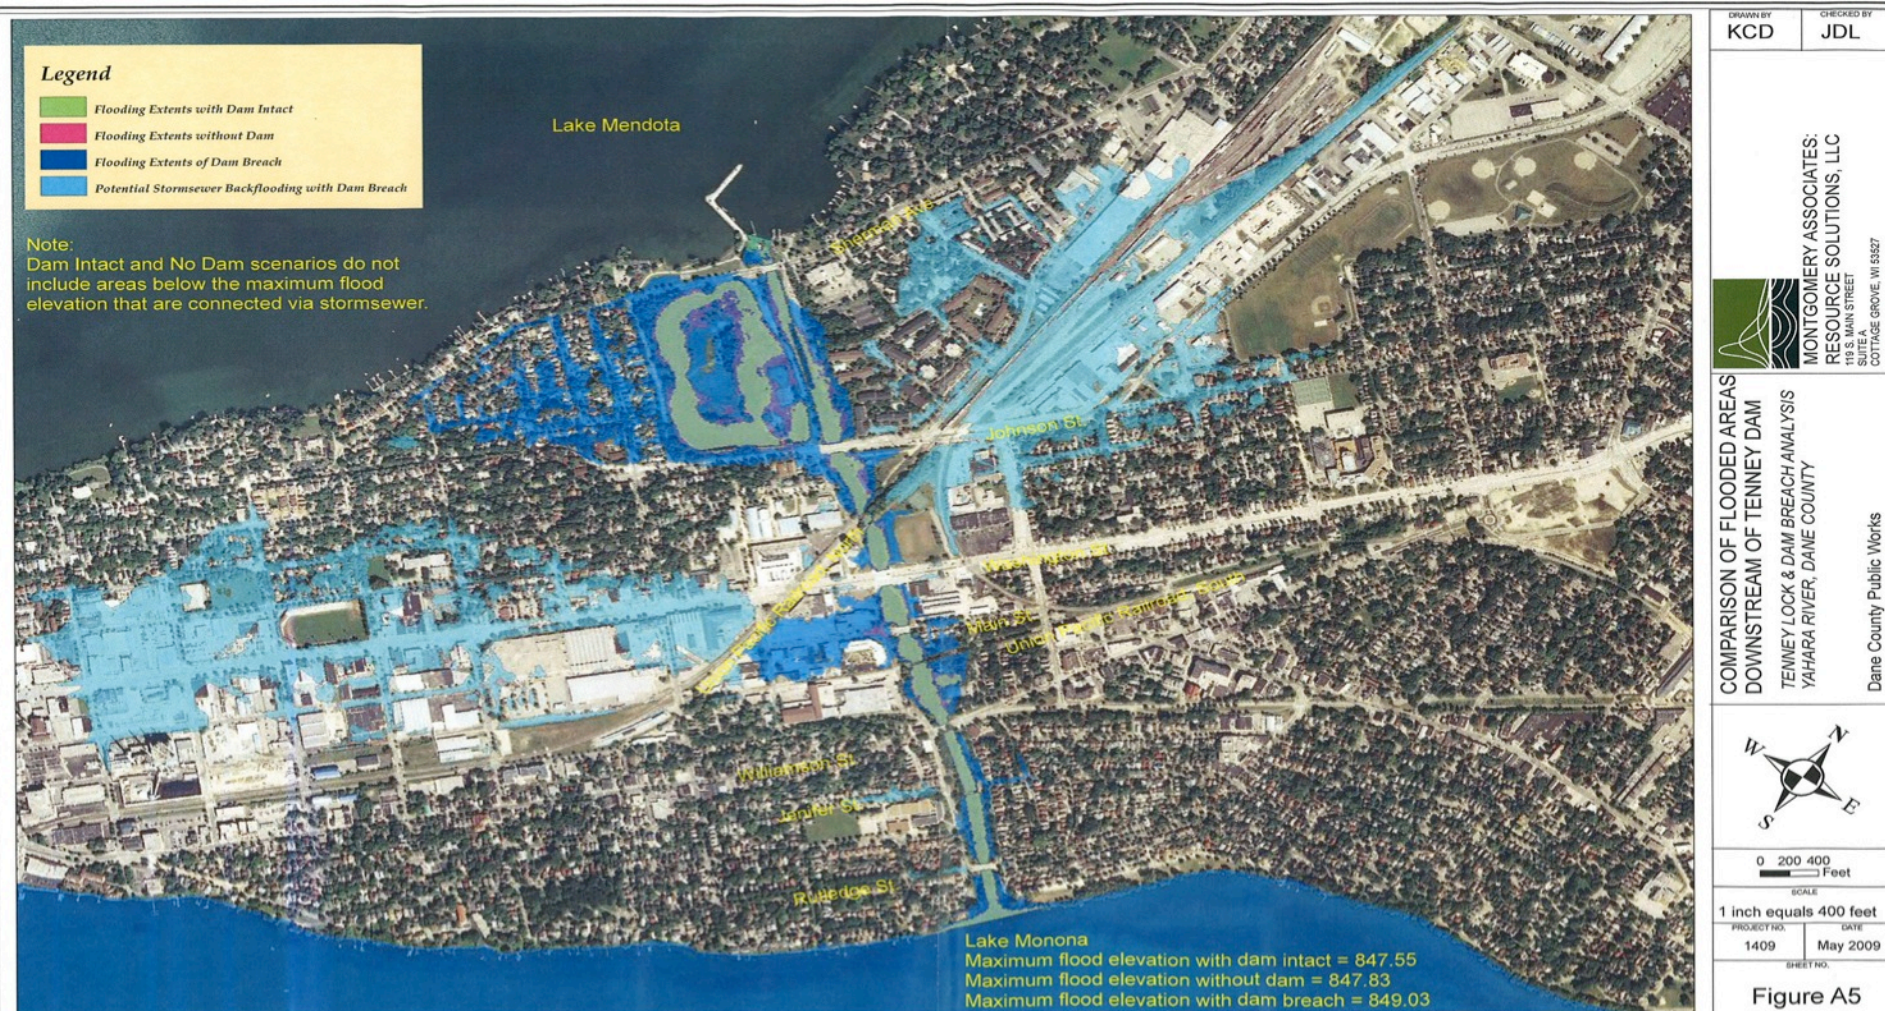
This map from a 2009 study shows the potential impacts of the 100-year flood under different scenarios

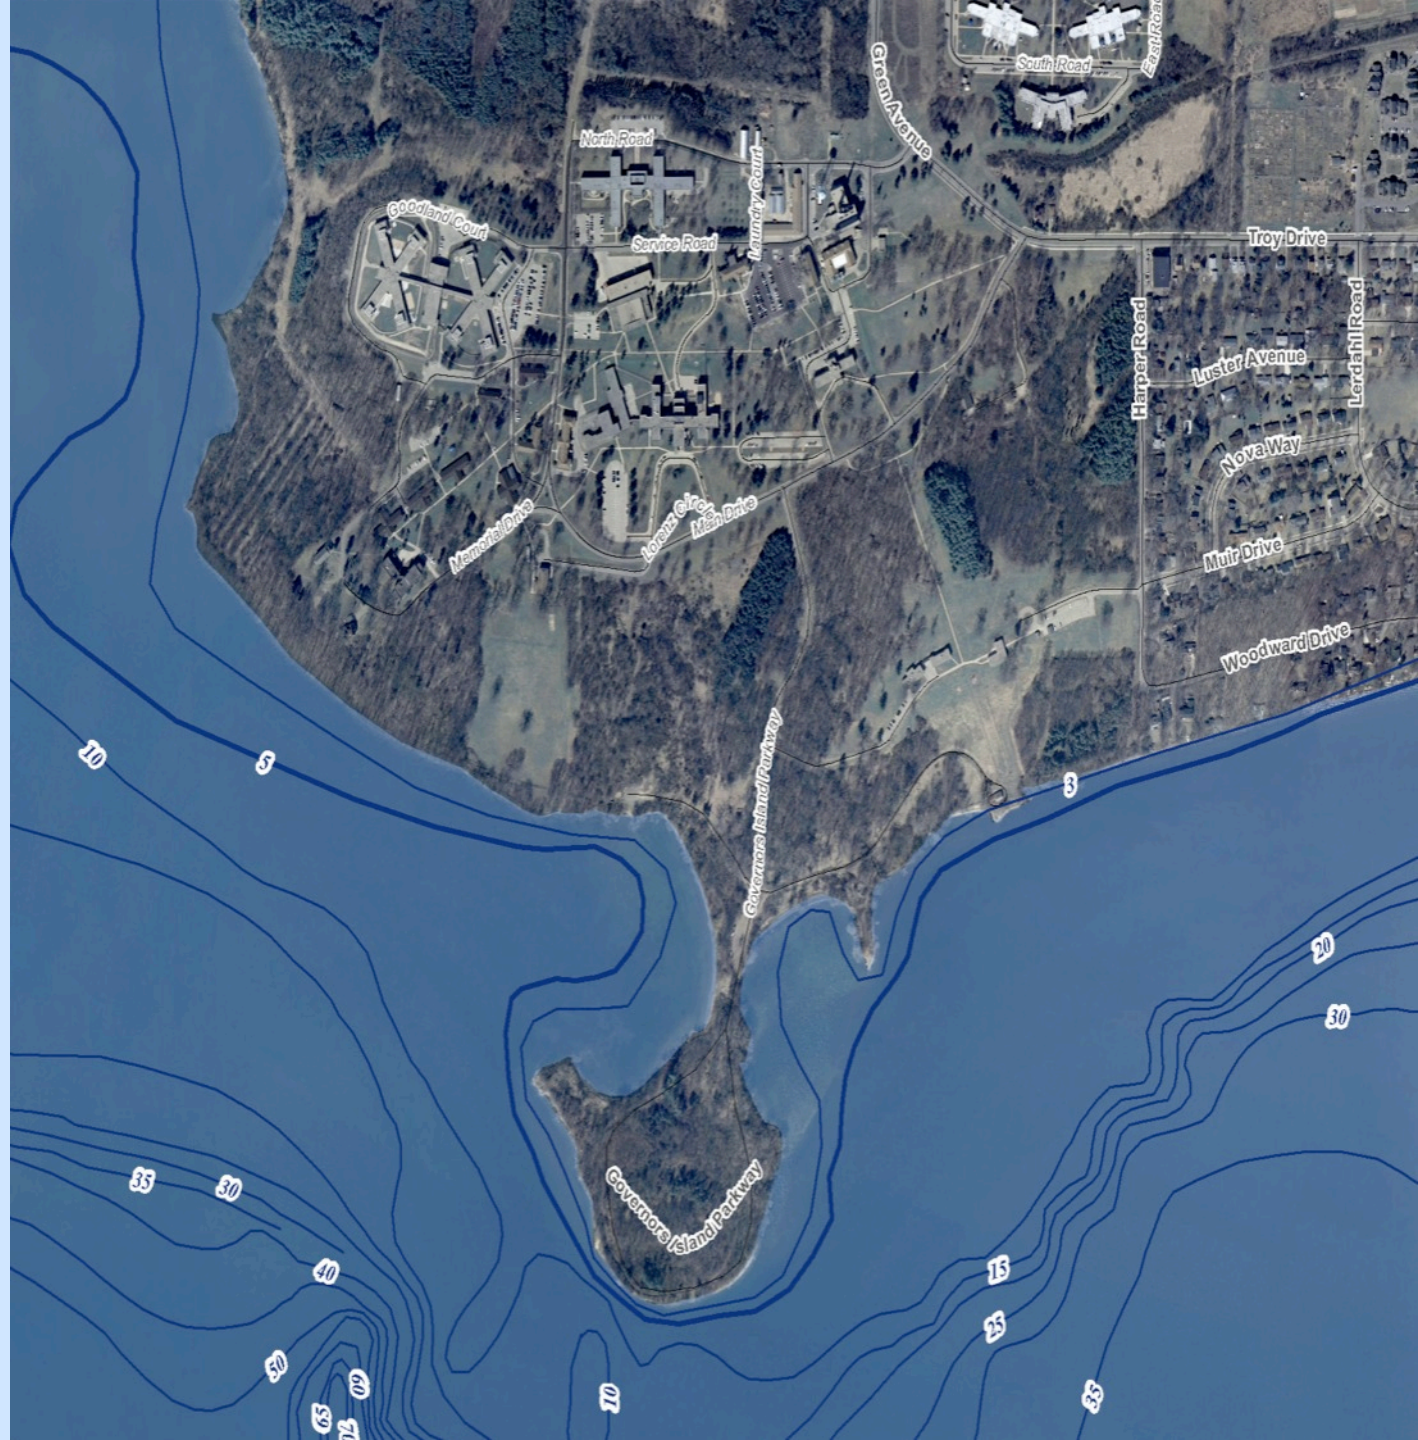
Governors Island area

dark blue
contour line
=
natural shoreline,
after lake is lowered
about 5 ft
