Toward a Natural Lake Mendota:

Capital Region Advocacy Network for Environmental Sustainability

Lake Mendota Level Recommendations v.2012.03.28

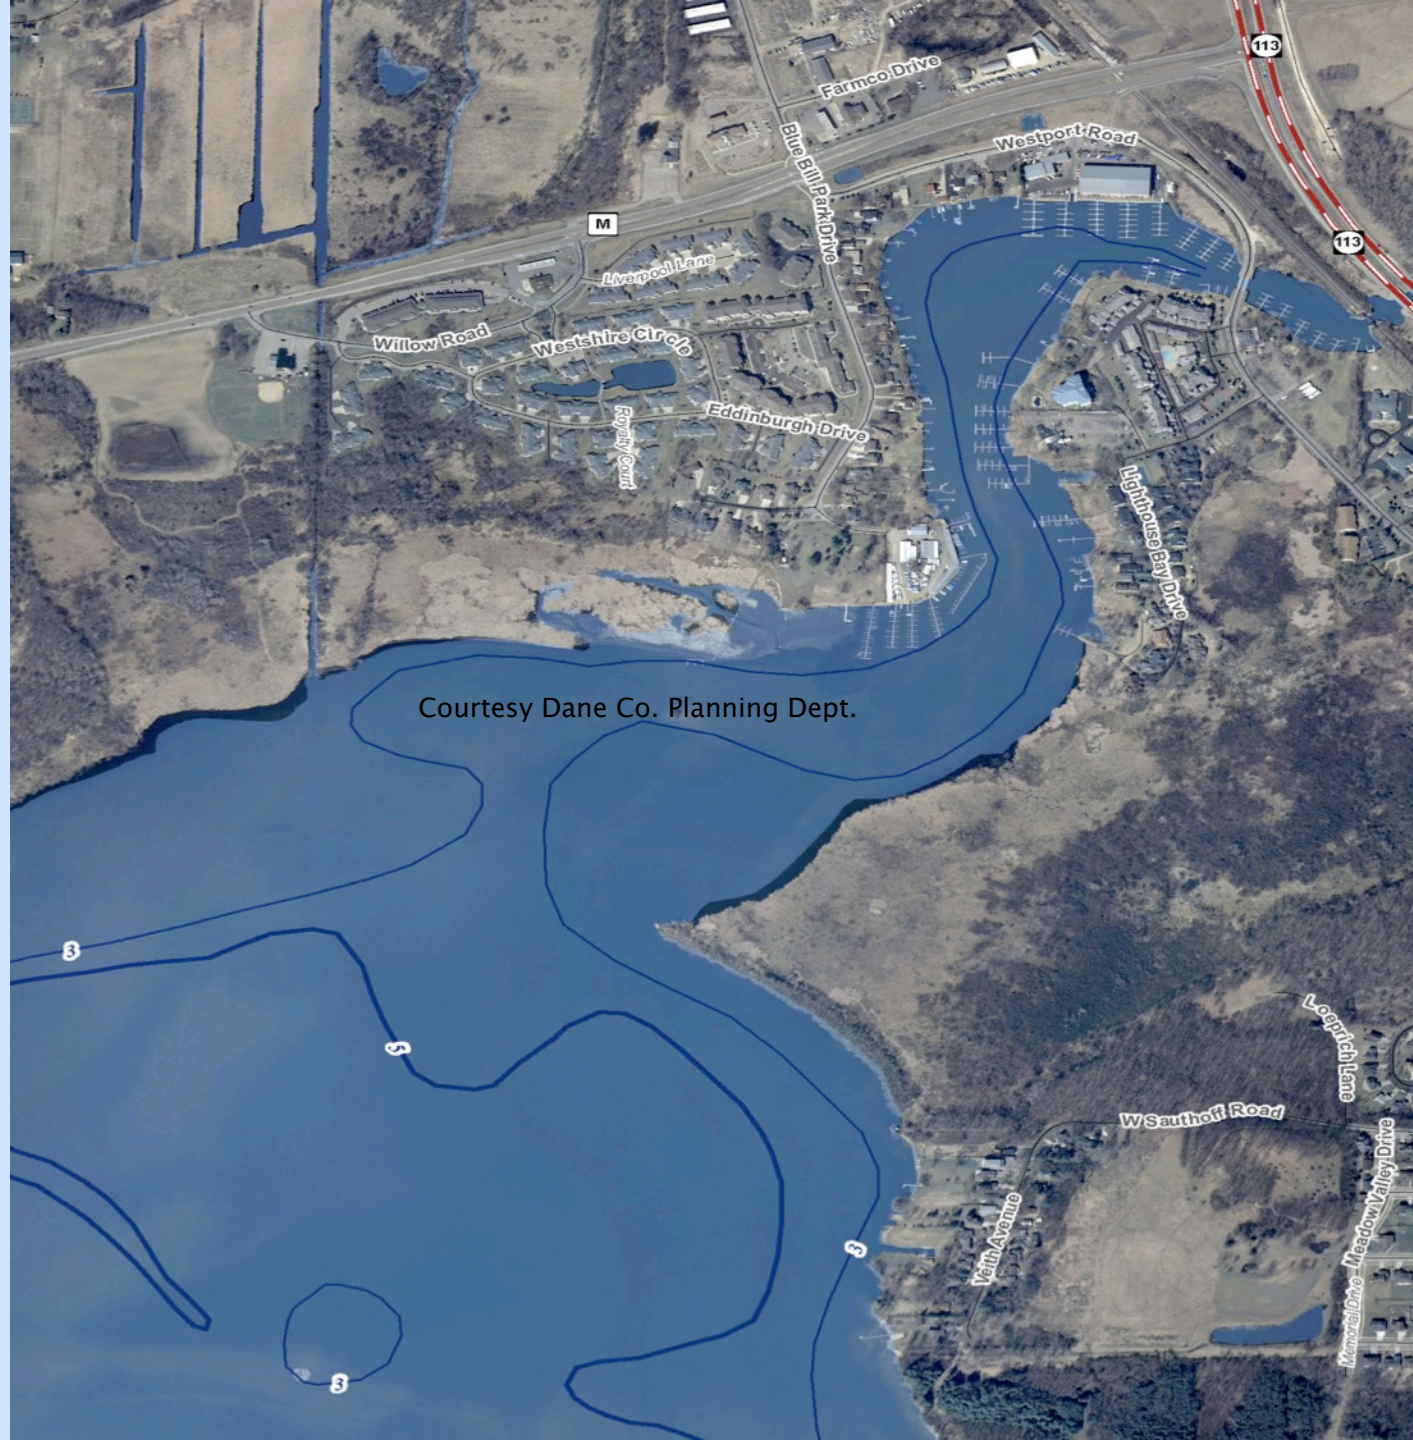
Yahara Estuary

natural shoreline,
after lake is lowered
about 5 ft
